Facility: AltEn, LLC
 IIS: 84069
 PCS: NE0137634

Facility Site Inspection Report

AltEn LLC - Storm Water Temporary BMP Check Map

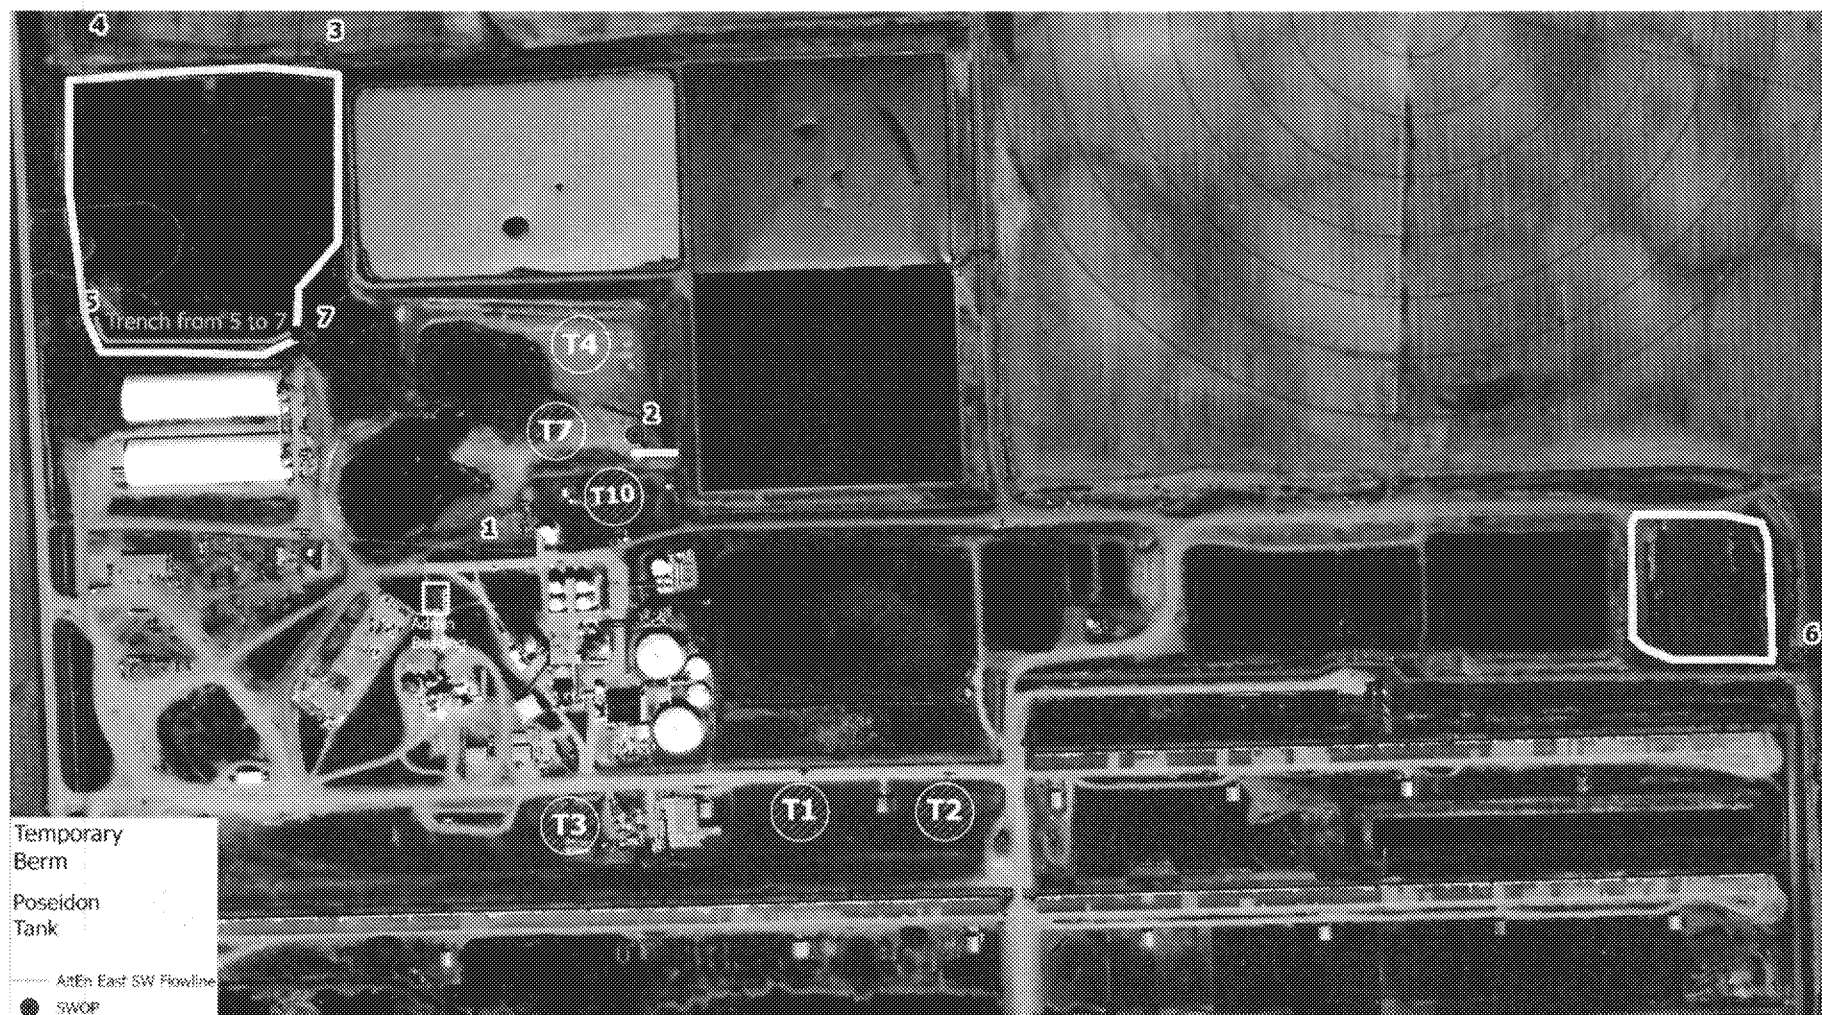
Storm Water Berms and areas of concern (the numbers below match the attached map)

Location	Inspected		Area Description	
	Yes	No		
1. Northeast side of the administration building	<input checked="" type="checkbox"/>	<input type="checkbox"/>	<i>Berm removed</i>

2. Southwest side of the south lagoon	<input checked="" type="checkbox"/>	<input type="checkbox"/>	pumped <input checked="" type="checkbox"/>	not pumped <input type="checkbox"/>

3. West side of the northwest lagoon	<input checked="" type="checkbox"/>	<input type="checkbox"/>	pumped <input checked="" type="checkbox"/>	not pumped <input type="checkbox"/>

4. North side of the north wet cake pile	<input checked="" type="checkbox"/>	<input type="checkbox"/>	<i>Does not accumulate runoff</i>	
5. County Road 10 (Hoop building)	<input checked="" type="checkbox"/>	<input type="checkbox"/>	pumped <input checked="" type="checkbox"/>	not pumped <input type="checkbox"/>

6. East wet cake pile (wet cake now removed)	<input checked="" type="checkbox"/>	<input type="checkbox"/>	pumped <input checked="" type="checkbox"/>	not pumped <input type="checkbox"/>
